**ROOT CAUSES OF ENGINEERING COMPLACENCY ON
AVIATION AND AEROSPACE SAFETY**

THESIS

**Presented to the Faculty of
The University of Houston Clear Lake
In Partial Fulfillment
of the Requirements
for the Degree**

THE UNIVERISTY OF HOUSTON-CLEAR LAKE

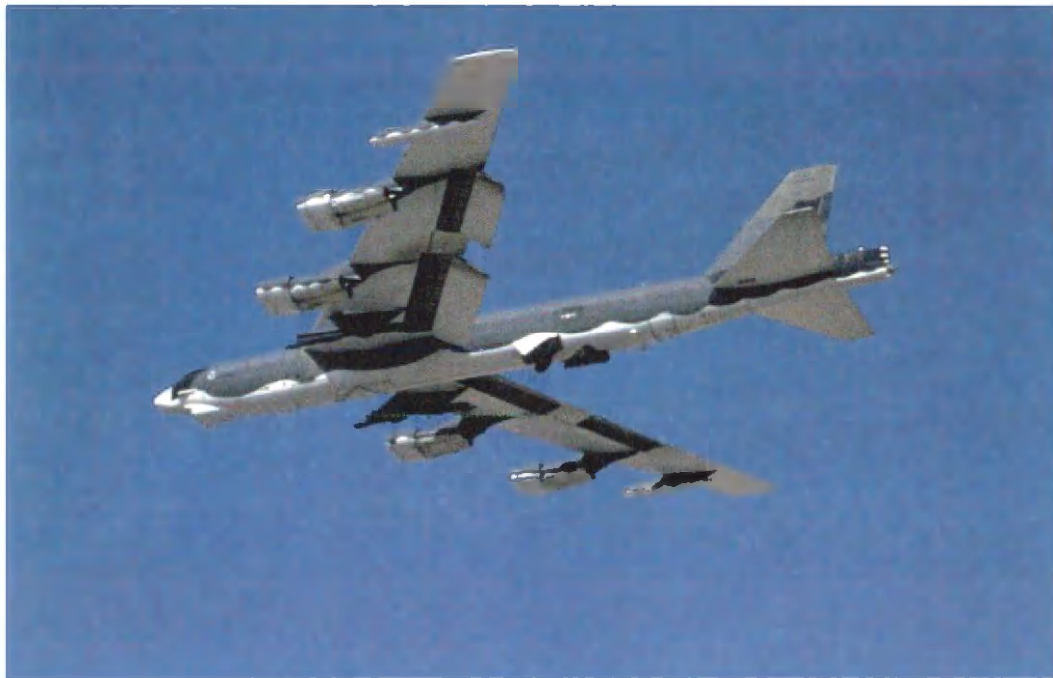
Figure 10: B-52 Stratofortress

The B-52, Stratofortress, is a long-range, heavy bomber that the U.S. Air Force uses to perform a variety of missions. It is approximately 159 feet in length and has a wingspan of 185 feet, with a maximum takeoff weight of 488,000 pounds. Eight Pratt & Whitney engines, each producing up to 17,000 pounds of thrust, power the B-52. It travels at a cruise speed of 650 miles per hour and at a range of 8,800 miles (United States Air Force, 2010c). Figure 10 on the following page shows a B-52 aircraft (United States Air Force, 2010c).

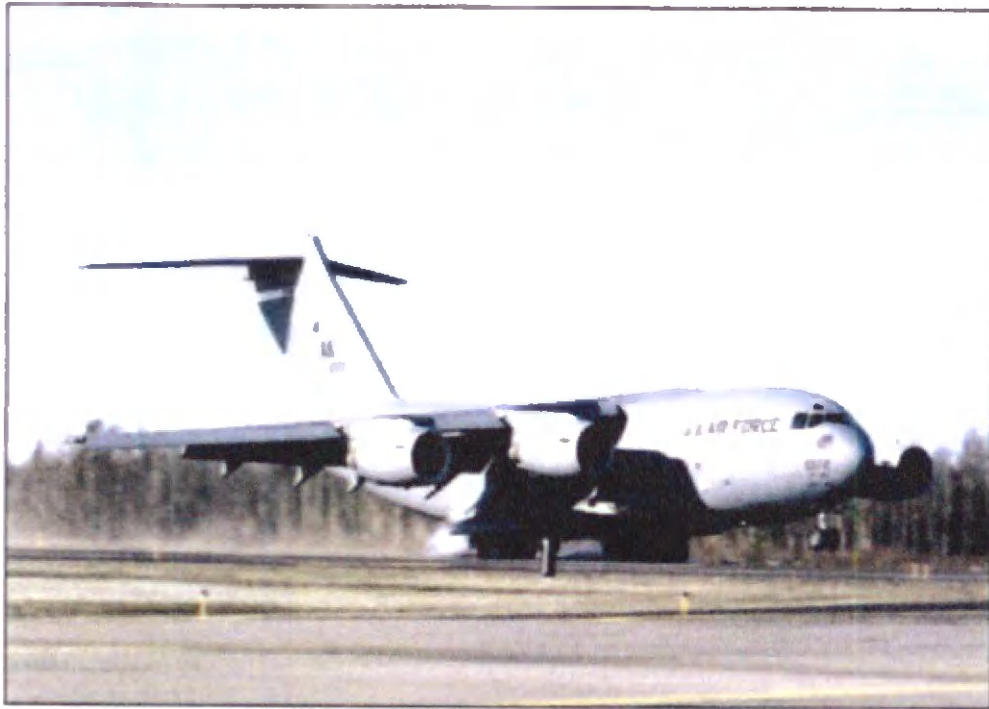
Figure 13: C-17A Globemaster III Cargo Transport

The C-17A is one of the U.S. Air Force cargo aircraft. It is used to deliver troops and cargo to operating bases or deployment areas. The aircraft is also capable of performing tactical airlift and airdrop missions. It is approximately 174 feet in length and has a wingspan of 169 feet, 10 inches, with a maximum takeoff weight of 585,000 pounds. Four fully reversible Pratt & Whitney engines, each producing 40,440 pounds of thrust, power the C-17A. The aircraft's cruise speed is 450 knots and its range is global with in-flight refueling capabilities. A typical crew for a C-17A will consist of a pilot, co-pilot, and loadmaster (U.S. Air Force, 2010d). Figure 13 below shows a C-17A Globemaster III cargo transport (U.S. Air Force, 2010d):

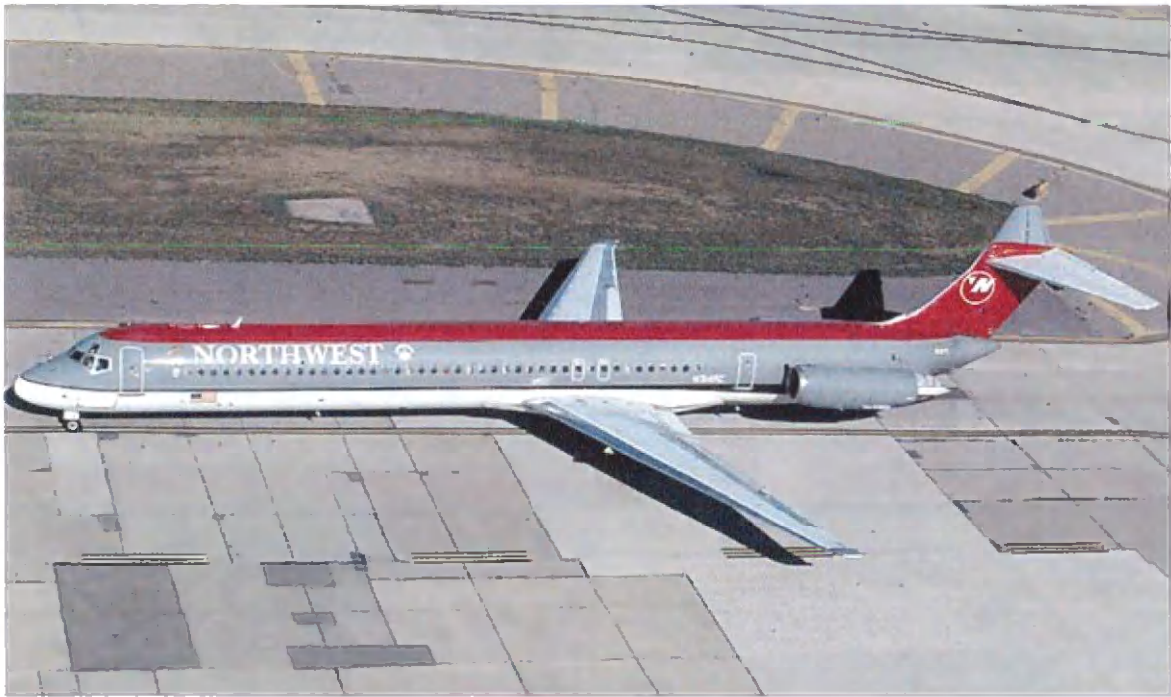
Figure 16: McDonnell Douglas DC-9-82

The DC-9-82 is manufactured by McDonnell Douglas and is powered by two Pratt & Whitney turbofan engines capable of producing 40,000 lbs of thrust. It is approximately 147 feet in length with a wingspan of 107 feet. It travels at a speed of 574 miles per hour and has a range of 1,800 statute miles. Figure 16 shows a McDonnell Douglas DC-9-82 (Pries, 2002).

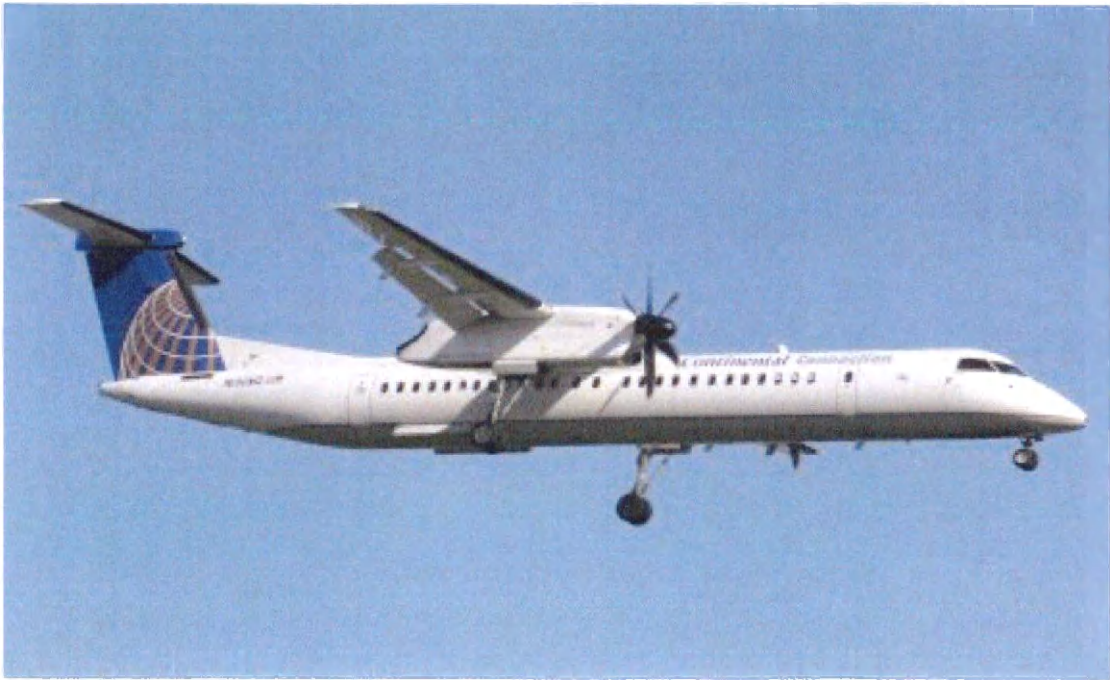
Figure 17: Bombardier Q-400

Colgan Air operates the Bombardier Q-400 on behalf of Continental Airlines. This aircraft is a twin-engine turboprop with a maximum cruise speed of 350 knots and a range of 1,260 nautical miles. The Q-400 has a length of approximately 107 feet and a wingspan of 93 feet (Transport Canada, 2001). Figure 17 on the following page shows a Bombardier Q-400 (Pries, 2002).
